Seismic Vulnerability Assessment

Kodiak Island Borough

G&E Engineering Systems Inc.

*G&E Report 87.01.05, Revision 0
February 12, 2006*

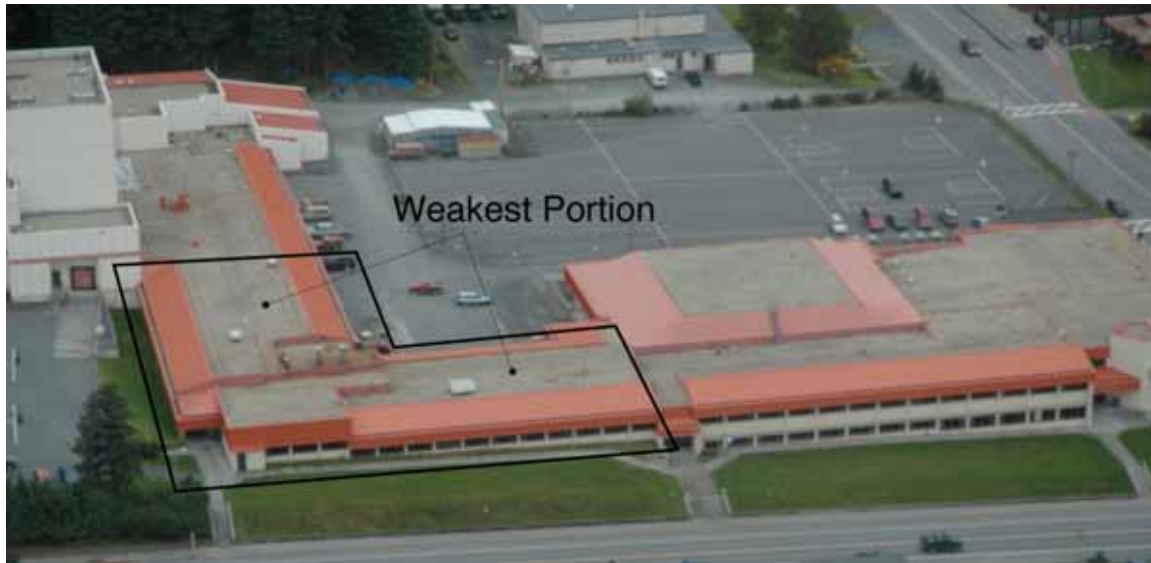
Figure 2-4. Aerial View of Building, Highlighting Weakest Portion

Summary. The weakest part of the building is the existing old 1952 wing and adjacent 1954 classrooms that use the same style of construction. These portions of the building use non-ductile reinforced concrete columns (typical vertical steel is 4 -#7 bars, with #2 stirrups at 12 inch spacing), aggravated by short column effects. Also, these portions of the building have no roof diaphragm system owing to the discontinuous monitor / attic level, and lack shear walls that extend to the roof level. To a lesser extent, similar exterior short column issues occur on the eastern two-level portions of the building, and allowance for adding some shear walls along the weak column lines in those portions of the building is provided in the suggested upgrades. Section 4 describes the recommended upgrades.

We examined a number of retrofit strategies for the Middle School. The primary upgrade concept is to provide shear walls along the outside perimeters of the building, to cure the non-ductile short column vulnerability (see Figure 4-1). The monitor level vulnerability will be solved by adding plywood atop the 3x6 sheathing, including the discontinuous step up section at the original attic (monitor level) windows. To the extent feasible, the upgrade will re-use existing materials. Over the interior corridor walls, additional plywood panels will be installed to provide continuity from the roof level diaphragm to the partial height hallway concrete walls. At most (not all) classrooms, the existing gypsum board partition wall will be replaced by a combination plywood wall, covered by gypsum board and wall finishes. In the two-story section of the building, selected exterior walls will be upgraded with additional shear walls.

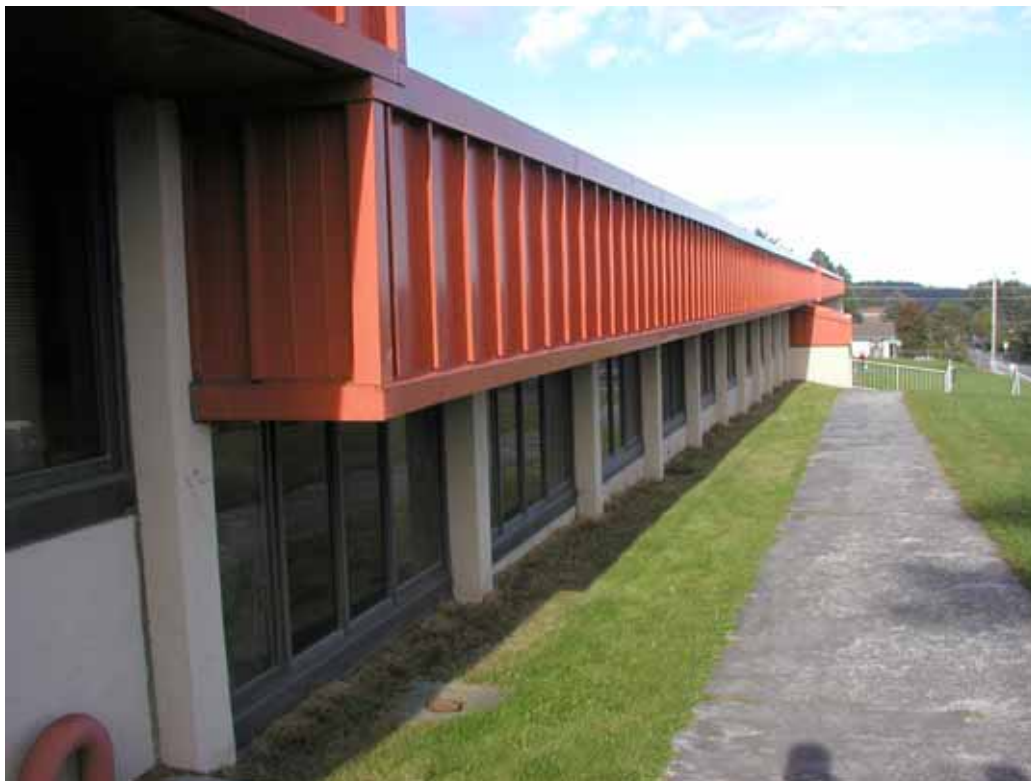
Figure 2-5. Middle School South Elevation (1952 Section)

Most of the current east, south and west facades, as well as limited portions of the other facades, use a combination of reinforced concrete footing wall, short reinforced concrete columns through a window level, and then a reinforced concrete wall up to the roof level. The reinforced concrete columns (Figure 2-5) use #2 bars as ties at 12-inch spacing.

While this type of column detail was commonly used prior to 1970, experience in past earthquakes now shows that this type of column is non-ductile, and the short column effect caused by the window configuration further aggravates the ductility demand on the columns under sufficiently large earthquakes.

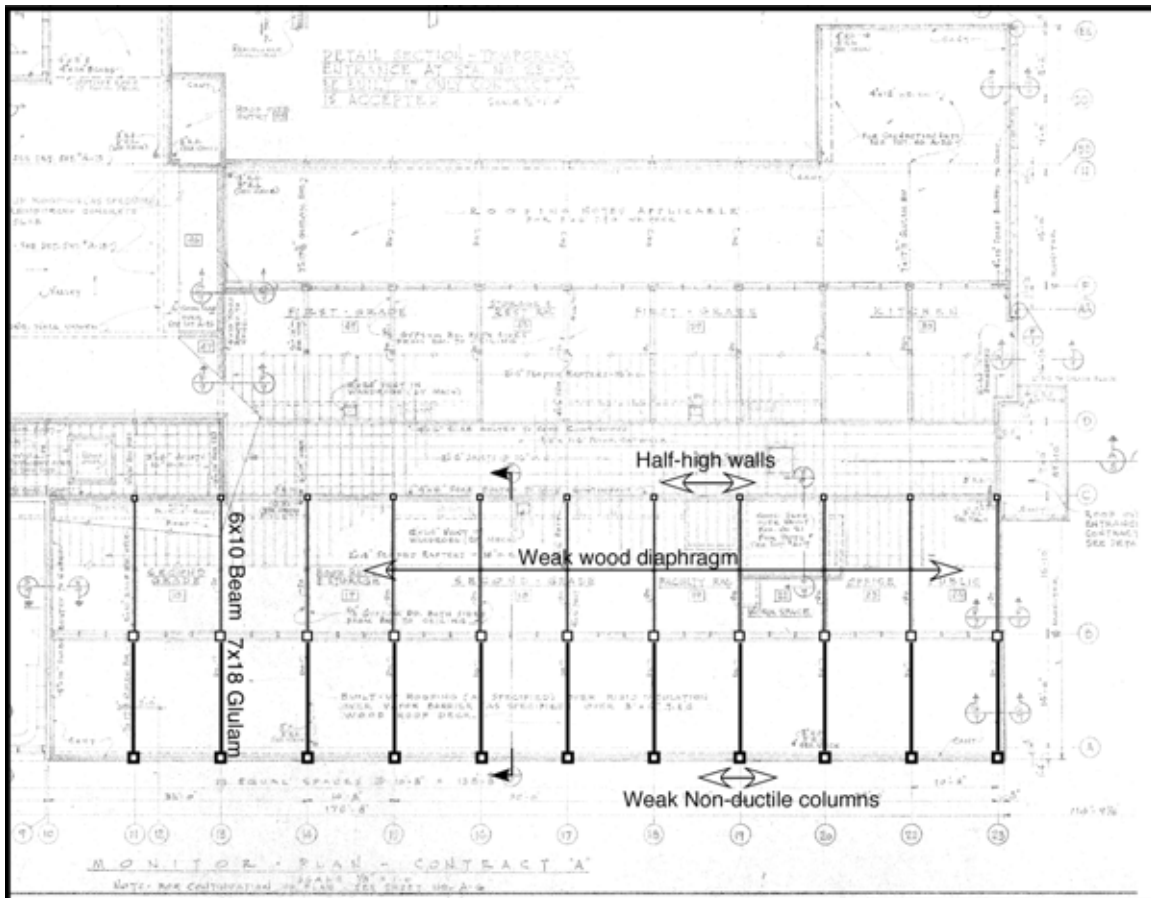
Figure 2-6. Middle School Plan, Highlighting Structural System (1952 Section)

caused by the monitor level substantially weakens the seismic load-carrying capacity of these portions of the building. Figures 2-6 and 2-7 highlight the weaknesses.

We evaluated the older portions of the building to determine its capacity to withstand seismic loading. The most severe weakness is the limited strength available by the outside reinforced concrete columns (open arrows, Figure 2-6); severe damage is expected to start at $PGA = 0.22g$. An earthquake with $PGA = 0.27g$ would be large enough to result in gross x-type cracking through most outside short columns, including severe distortions of the roof system. Once the outside columns crack, they have almost no ductility capacity to absorb drift while maintaining column integrity; concrete will spall and the vertical bars will buckle. Compounding this problem is that in the older parts of the building, the monitor level style of construction has essentially no roof diaphragm capability to transfer seismic wall and roof loads to other lateral force resisting system members. Figure 2-7 highlights that the existing 3x6 roof sheathing is discontinuous mid-way through the classrooms, and that the interior 4-inch concrete walls are not continuous to the roof level. The gypsum board walls that form the classroom dividers are weak (limited nailing and limited capacity by the gyp board), and the "wind bracing" from the attic level 6x10 beams use only light nails to transfer load. Considering the limited ductility available, we estimate short column failures and collapse at $PGA = 0.45g$, possibly somewhat less should the earthquake be a long duration subduction zone (like a M 8.5+ event with epicenter immediately offshore of Kodiak Island).

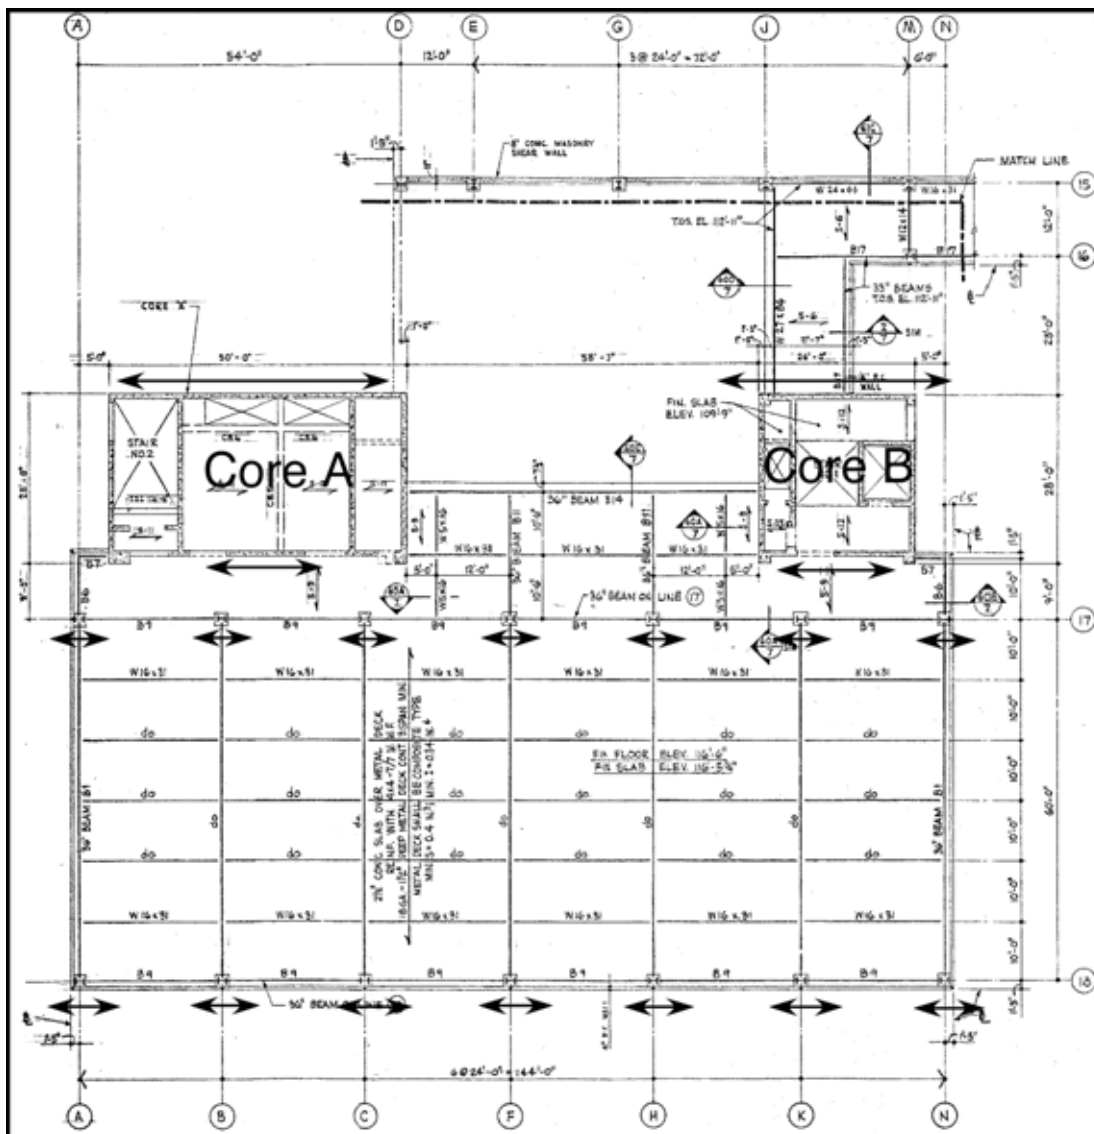
Figure 2-11. Seismic Load Path, East West Loading, Library (Plan)

towers, so the building will in fact not behave as the simplified code analysis would suggest. Instead, for east-west loading, the Core A and Core B concrete towers will act as stiff walls, and cause the columns along line 18 (southernmost line) to have more drift (and load) than a balanced stiffness design would assume. The substantial torsion response will also attract a lot more load to the Core A and Core B towers than would have been assumed neglecting the effects of torsion. Figures 2-13 and 2-14 show some of the cracks that have already formed in Core A, likely due to prior earthquakes ($PGA = 0.1g$ or so at this site), strongly indicating that the steel within the walls has already yielded in past earthquakes. Six separate visible cracks (about 1/16 inch) have already formed in these walls. This confirms that the walls will be greatly overloaded in earthquakes with $PGA = 0.47g$ (475 year return period) or higher, and that weaker elements of the Core (spandrel beams over openings) will be severely racked in such events.

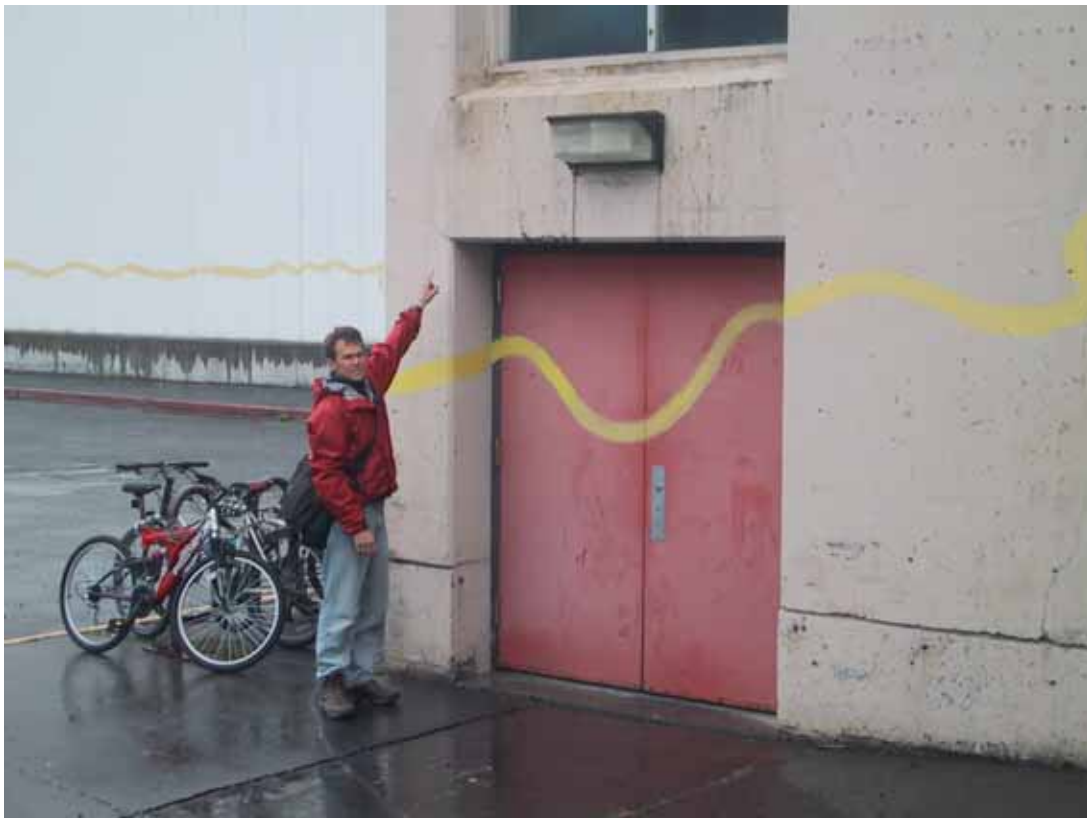
Figure 2-13. Column-Spandrel Cracks in Core A Above Door and Below Window

In the north-south direction, the reinforced concrete shear walls in the Core A and Core B towers provide the primary lateral seismic load path, with residual capacity of the steel column frame action that would begin to work only if the shear walls become overloaded. The building appears well balanced for resisting loads in the north-south direction.

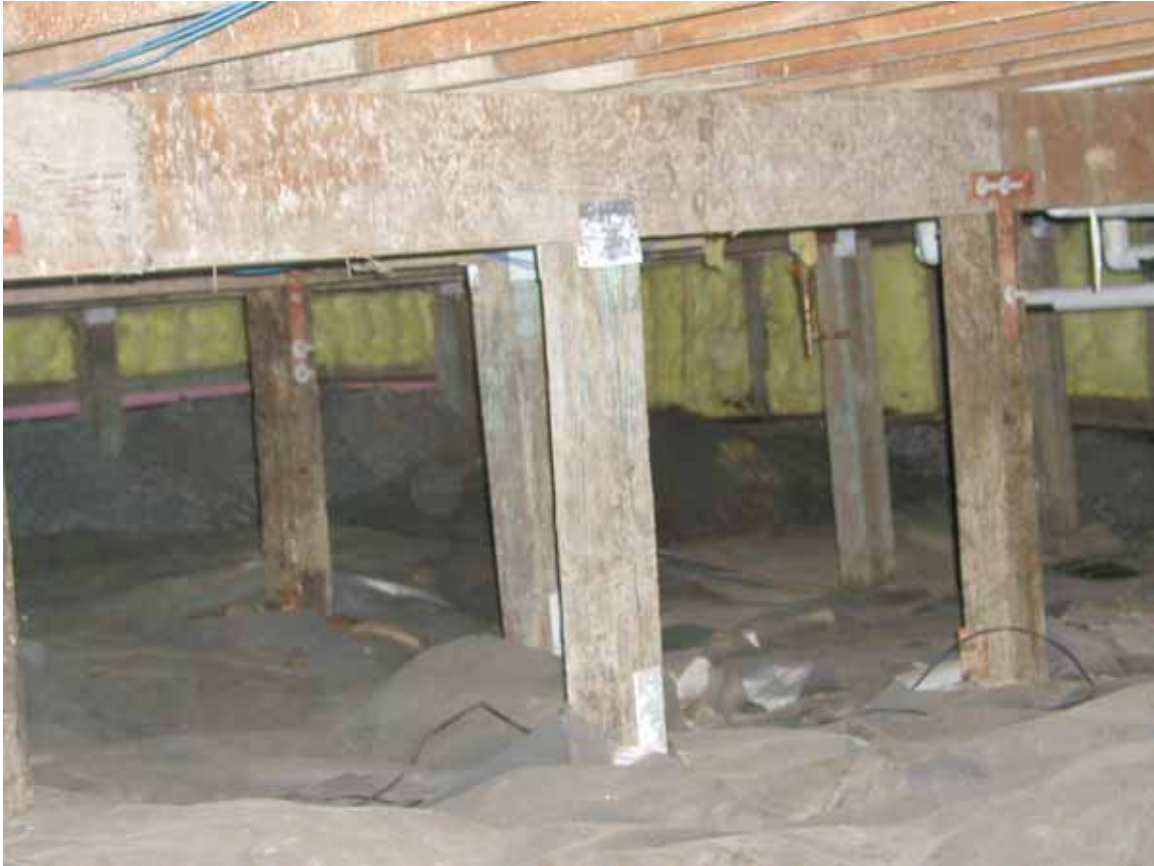
Figure 2-16. Crawl Space Under Central Section (1969 Portion) of Ouzinkie

The central portion of the school is the original construction, designed in 1969. This portion includes classrooms and a multi-purpose gym (since converted to classroom use). The exterior walls use 0.5 inch plywood, with unspecified nailing. The roof uses plywood with unspecified nailing. The ground level wood floor is supported by wood beams, which in turn are supported on 6x6 wood posts to small footings resting on the rock-like foundation (Figure 2-16). There are no cross bracing members or shear walls that provide load path continuity from the first floor to the foundation shown on the original drawings; nor were any observed in the field. The exterior walls shown in Figure 2-16 show insulation, with exterior cladding not connected to any foundation at all.

Figure 4-3 shows the layout of the new foundations and seismic bracing under the central portion. The cross bracing would be similar to that seen in Figure 4-4 that is used on the southern side of the building. The new foundations and bracing would be sufficient to address the uncertain nailing system in the floor diaphragm by creating a series of short sub-diaphragms. On the northern side of the building, the double height of the facility coupled with the taller distances between the floor and foundation suggest the installation of grade beam footings along the perimeter and installation of plywood shear walls on all four sides. In final design, the selection of steel rod cross bracing or plywood walls could be modified to reflect the simplest installation method as well as access issues.

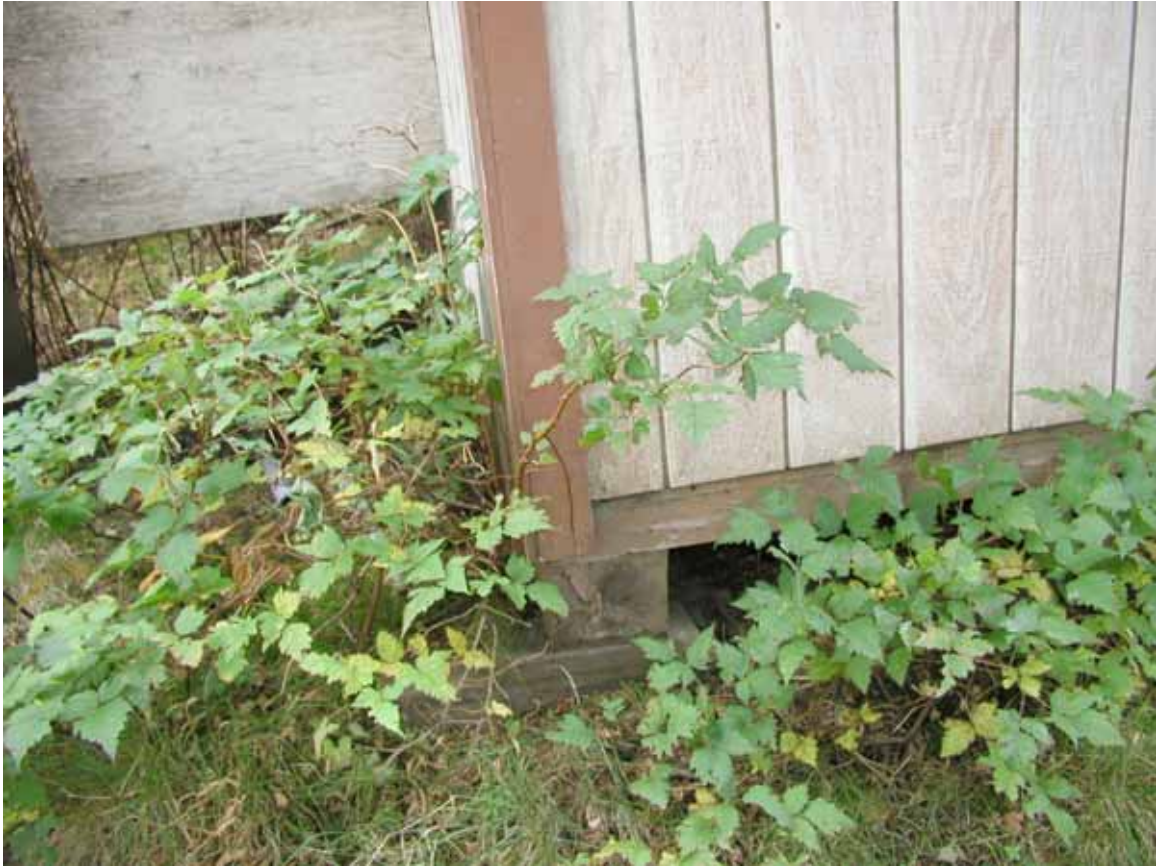
Figure 2-17. Emergency Generator Building Foundation

To the far east end of the site is a small building used to house the generator for the school (Figure 2-17). This small building has no foundation and is highly susceptible to movement under strong ground shaking. If the building moves, it will likely break fuel lines and other utilities that enter the building.

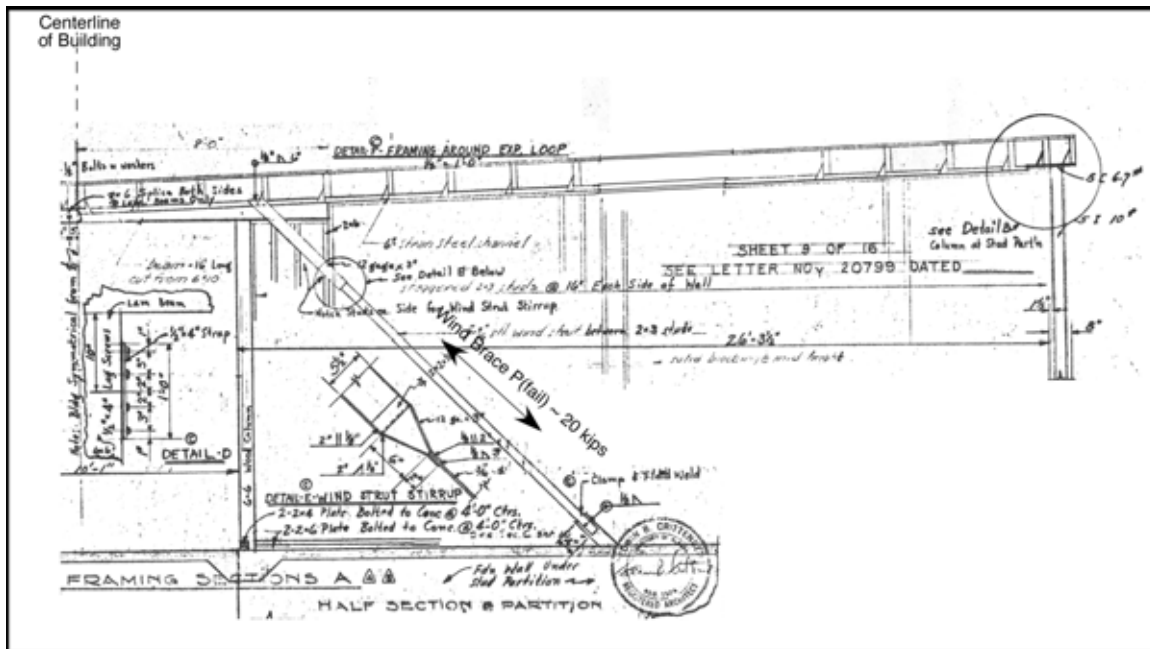
Figure 2-21. Cross Section Through Classroom Wall (Typical for 1946 Section)

The only lateral load resisting element in the east-west (transverse) direction of the 1946 building is the "wind brace". There are two 0.5" gypsum boards acting as sheathing on 2x3 wood studs that form the partition walls between the classrooms, but these have little if any seismic capacity and uncertain nailing schedule. This wind brace is made up of a 3/16" x 3" piece of steel, welded at several connection points with 1/8" thick welds, and then connected to a 6" steel channel (collector) at the roof level, and then connected (uncertain on the drawings) via straps to the 4" concrete slab on grade. This element can take tension loads only. The three sets of welded connections along its length cannot be relied upon to be "ductile", as there are large stress risers at each discontinuity. Even so, the nominal yield strength of the wind strap is likely at least 15 kips, more likely about 17 kips, and could be as much as 20 kips. Assuming that the entire roof weight for two classrooms (one either side of the central corridor) must be taken by one wind strap, and allowing no snow load at the time of the earthquake, and assuming there is a 50% margin above these values available, then the wind strap should break at PGA ~0.27g (assuming the original light weight 1946 construction). Once the wind strap breaks, then there is some residual strength afforded by the exterior wall columns (four 5I10), which in bending could take about PGA = 0.25g with ductile response and reasonable life safety assurance. Given the relative flexibility of the building elements, it is likely that the wind strap will take the vast majority of the seismic loads until it breaks, after which the 5I10 columns provide some margin. However, for PGA large enough to break the wind straps (about PGA = 0.30g), the remaining 5I10 will fail code levels at about the same PGA level. Thus, extensive damage is likely at PGA about 0.30g in the east-west direction.

The recommended upgrades are to replace the interior classroom division walls (8 total) with new plywood shear walls; install new concrete footings under the plywood walls to take the overturning loads; remove portions of the built-up roofing and then upgrade the nailing of the existing plywood to the new plywood shear walls; remove the exterior glass block walls above the masonry infill walls and replace with concrete wall with suitable attachment to the masonry units below and the roof system above. These upgrades would be done assuming $V = 0.47g * 2.5 / 6 = 0.196W$, where W is the current weight of the building, including provision for likely snow loads.

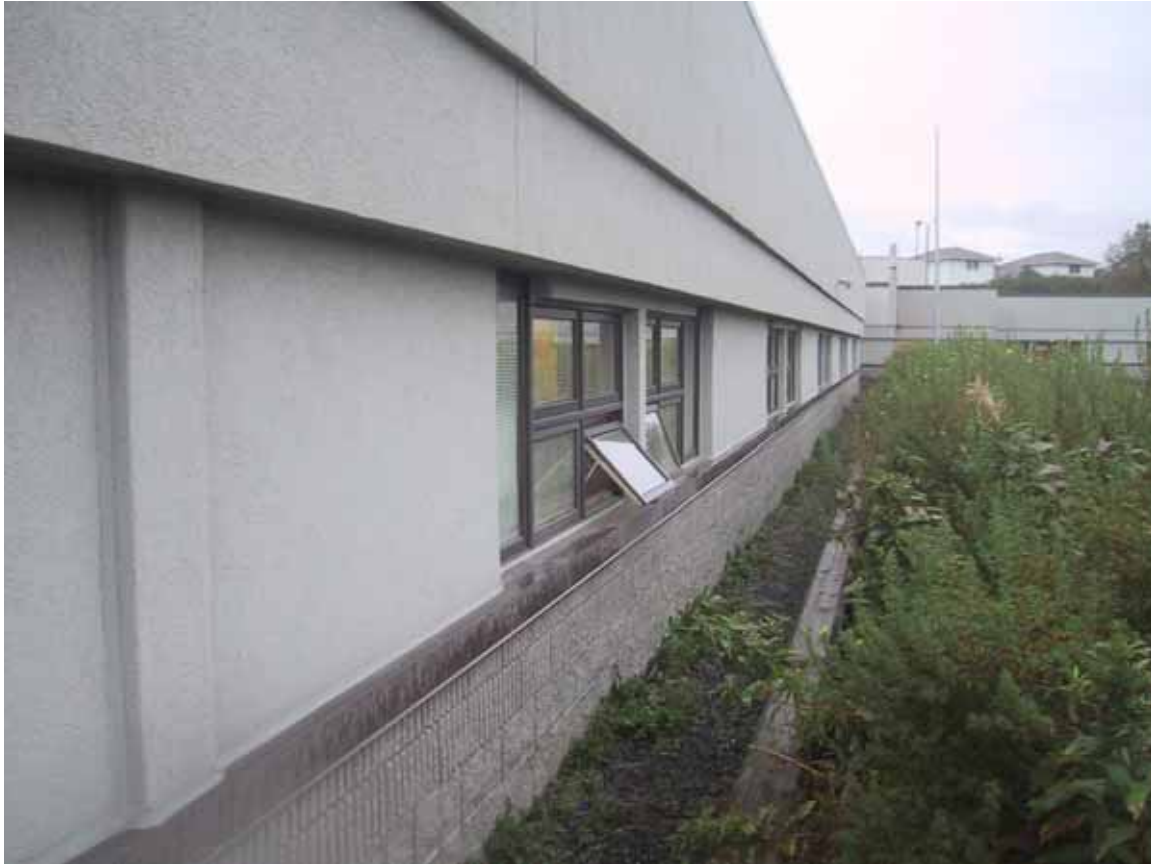
Figure 2-22. North South Exterior Wall. Photo taken looking south, 20 feet from north edge of building

1946 drawings show that there were windows running completely along this wall, with glass block walls above the windows. The stucco siding was added over the original glass blocks as part of the 1986 re-model of the building. Under the stucco are partial height masonry units, reinforced with #4 bars at 32 inches vertically, but these block walls were not continued all the way up to the roof diaphragm level. Instead, these walls are lightly attached to the original steel angles that formed the boundary elements above the old windows; there is no documentation to show that these angles were originally installed in a manner to act as collectors, so the force resisting system to take north-south loads from the roof level into these new reinforced masonry walls is uncertain.

With the 1986 renovation of the outside masonry walls, as well as new built-up roofing, the weight of the building was increased by about 80%. In its current configuration, the outside masonry walls can take some east-west loading (acting as cantilevers). The current building should remain elastic up to $PGA = 0.10g$ and should provide reasonable life safety assurance up to $PGA = 0.25g$.

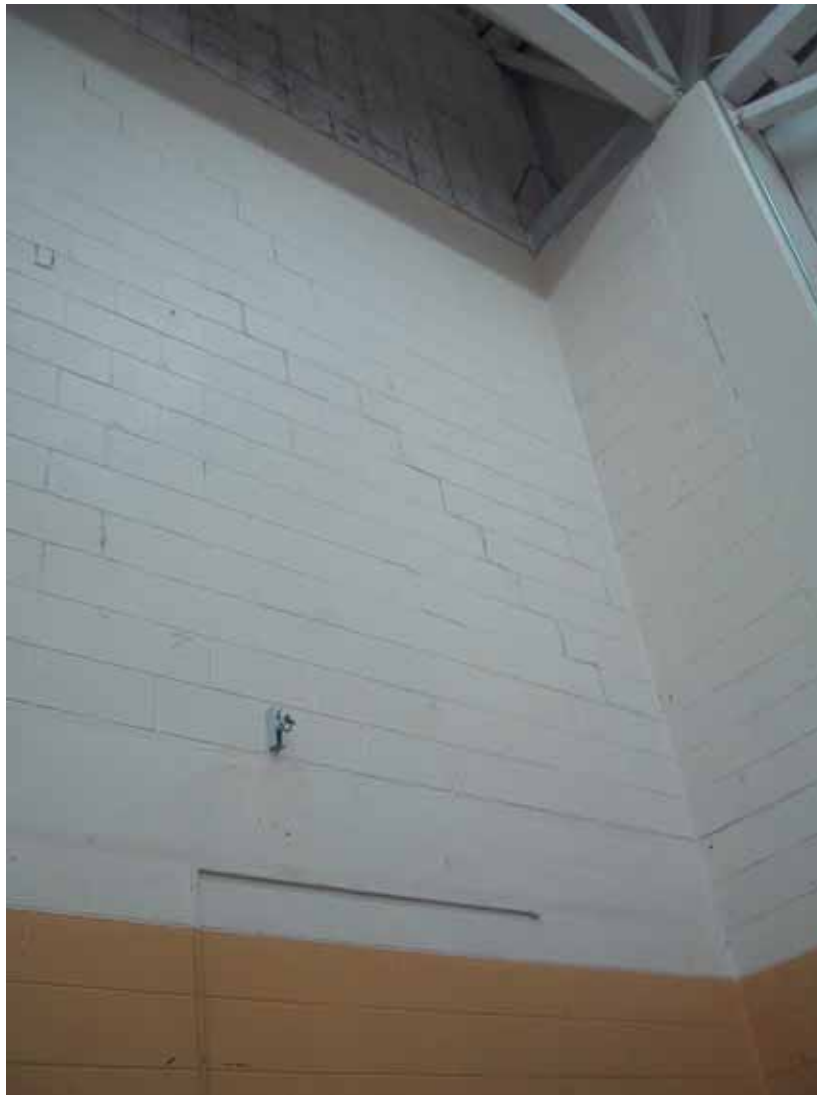
Figure 2-24. Non-Structural Wall Cracked, Northeast Corner of Gym

An evaluation of the building was performed to determine the likely cause of the cracks.

- the east wall would not be quite strong enough to create yielding in the wall, assuming the vertical and horizontal steel were in fact placed as suggested on the drawings. Possibly, a stronger wind did occur, and that might have cracked the walls.
- Third, this building has experienced earthquakes in the past, probably on the order of $PGA = 0.1g$ to $0.15g$. Owing to the location and stiffness of these walls, the theoretical strength of each wall would be reached at $PGA = 0.13g$ or so. Even though earthquake forces are two way (wind being one way), and the cracks only show in one way loading (as if wind was the loading mechanism), the earthquake loading might have caused the cracks, as in the reverse direction loading most of the seismic load would go to the exterior steel braced frames.

- Alternative 2. The existing walls can be repaired (epoxy injection or with a thin concrete shotcrete wall attached), and the connections of the walls can be modified to essentially unhook them from the exterior braced walls and the roof diaphragm. In this way, the building will perform as originally intended, with reasonable life safety assurance for $PGA = 0.40g$. The cost to perform this work is \$40,000. This would somewhat reduce damage at moderate levels of ground shaking and slightly improve the performance of the building at high levels of shaking, owing to the reduced damage to the roof diaphragm at the masonry walls.

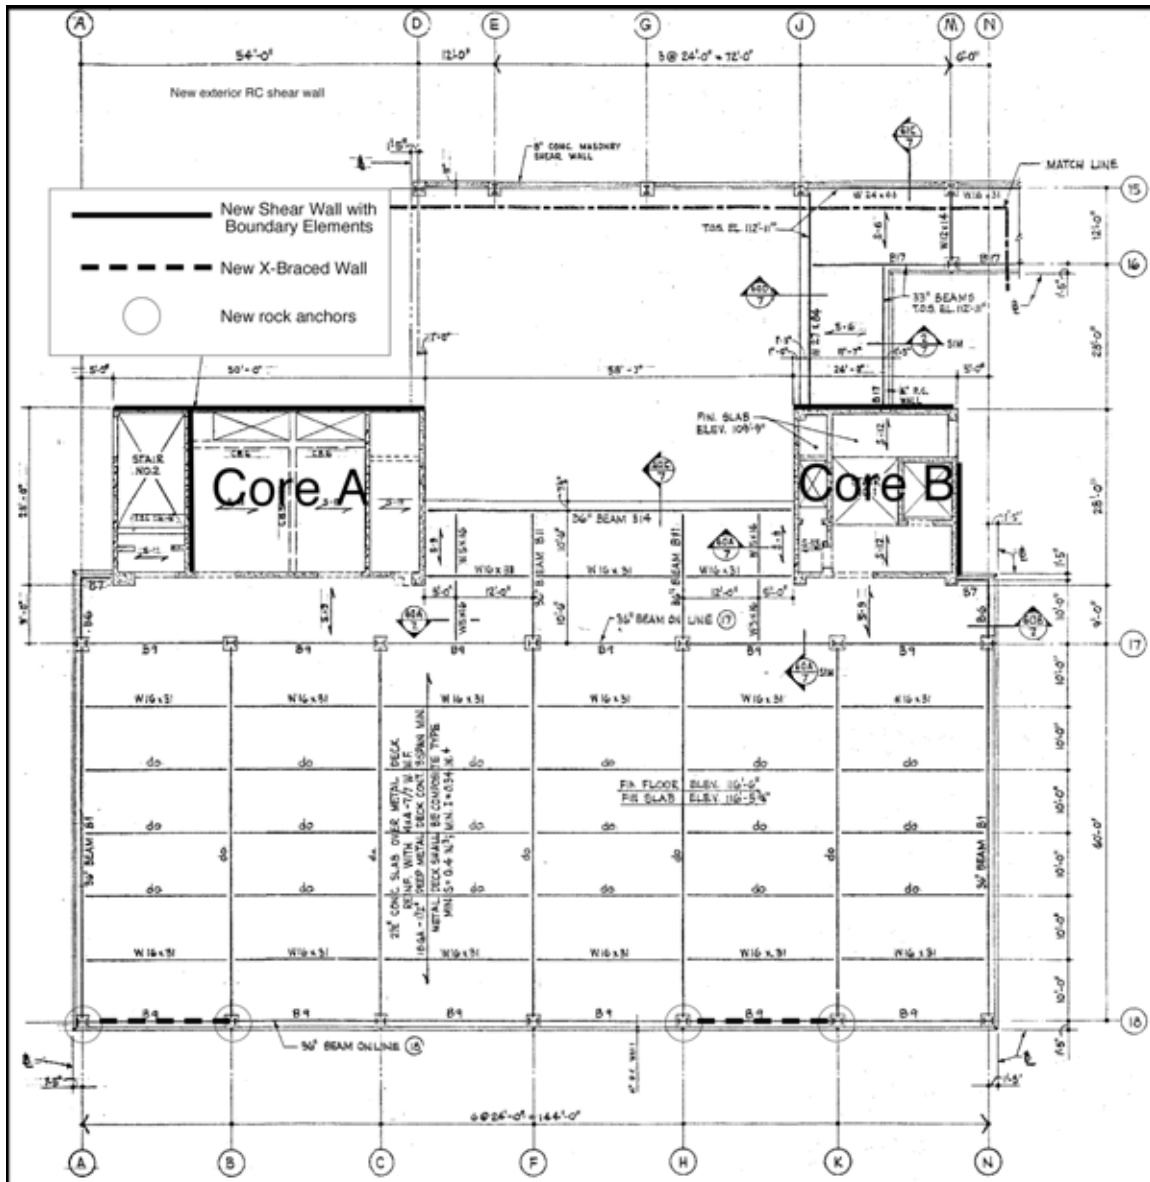
Figure 4-2. High School Library – Location of Seismic Upgrades

significant chance of collapse for offshore earthquakes (M8+) that produce 60+ seconds of shaking with PGA much over 0.3g.

Given that the building might experience earthquake loading in its remaining design life on the order of $PGA = 0.47g$ to $0.56g$ or so, upgrade is suggested for the building. The upgrade strategy is to add steel cross braces at two bays on line 18 (south façade, Figure 4-2) (preferred, keeps windows open, with some bracing visible; shear walls would close off windows). While these new braced walls will materially improve overall performance, the observed accumulated damage in Core A suggests that the walls of Cores A and B should be further reinforced to obtain a balanced design. Therefore, four additional bays (one each on the west and east facades adjacent to concrete floor diaphragms and two on the north face) will have reinforced concrete wall upgrades, in order to balance the stiffnesses of the structure and limit excessive torsion in the floor
